A Red Light Running (RLR) Photo Enforcement System was installed at the intersection of Central Avenue and Rodenburg Road on September 16, 2009 on the southbound approach, after finding limited success with other attempted measures to promote safer driving and improve compliance with traffic laws. The following statistical analysis was performed through 2015. Calendar year 2016 was not included as the Illinois Department of Transportation (IDOT) has not yet completed collecting all data. The statistical analysis will be updated annually, as collected data becomes available from IDOT.

Central Avenue and Rodenburg Road Roselle, IL

- RLR Photo Enforcement System monitors violations occurring on the southbound approach of the intersection
- RLR Photo Enforcement System installed: September 16, 2009

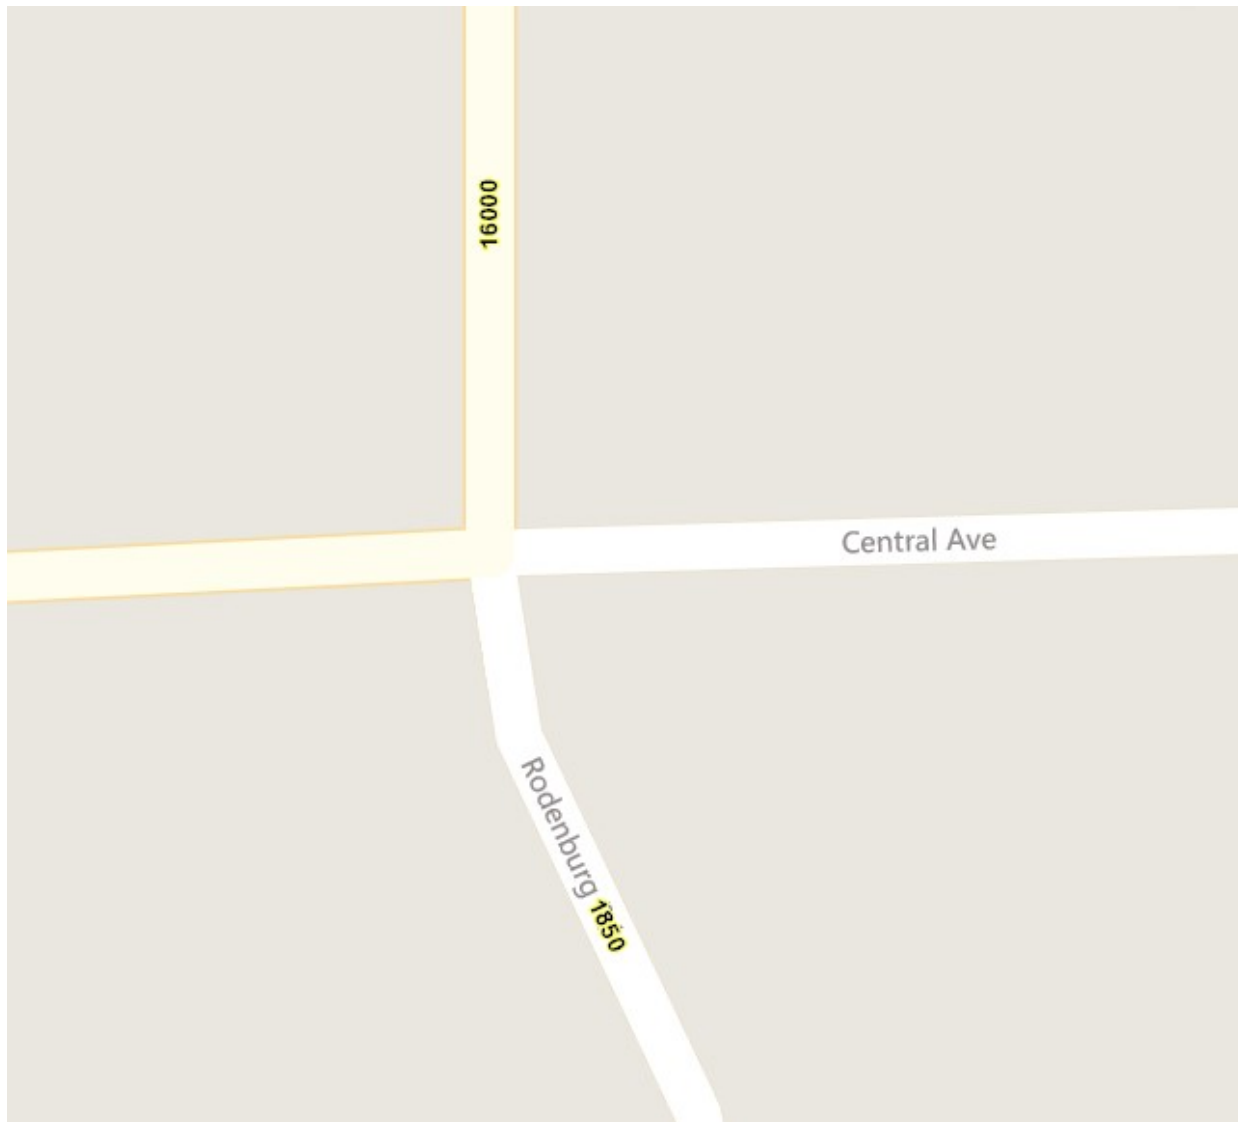
Average Daily Traffic

Data was obtained from the Illinois Department of Transportation's website
www.gettingaroundillinois.com.

Central Ave. & Rodenburg Rd.

Southbound ~ 16,000

Northbound ~ 1,850
